## How Asheville Restored Clean Water After Hurricane Helene

## **CASE STUDY**

City of Asheville Asheville, NC

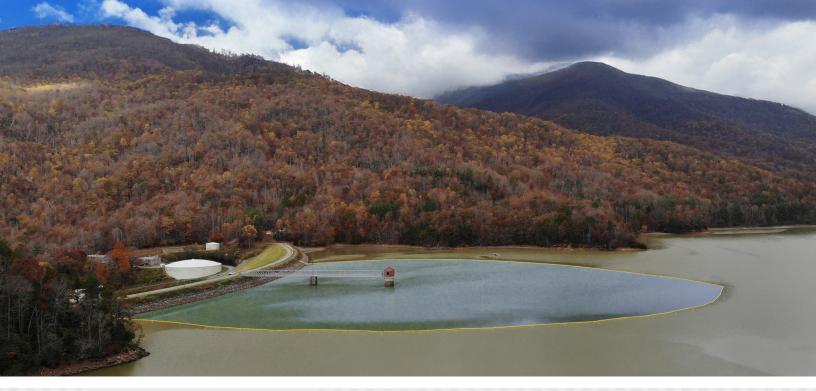
A photo of our turbidity barrier installed at the city's reservoir.

**SOLUTION:** After assessing the reservoir's conditions through detailed discussions, it was determined that Type 2 turbidity barriers, along with customized anchor kits for the reservoir's 300-foot depth, would provide the ideal solution. To ensure proper installation, the team conducted a video call with the contractor, offering clear guidance on deploying the barriers and anchor kits. Recognizing the urgency of the situation, production began immediately after receiving the order.

**RESULT:** In less than a week, the order was completed and shipped. Production worked diligently to build the turbidity barriers while a dedicated crew fabricated the custom anchor kits. The entire order was delivered to the job site early Monday morning the following week, enabling the city to swiftly implement the solution and restore water quality to its main reservoir.
